# New York State Department of Transportation

## Yellow Flag NB2258W001

**BIN: 1065318**

Location: Span 136, Stringer S2 at Pier 136 over 3rd Avenue Eastbound.

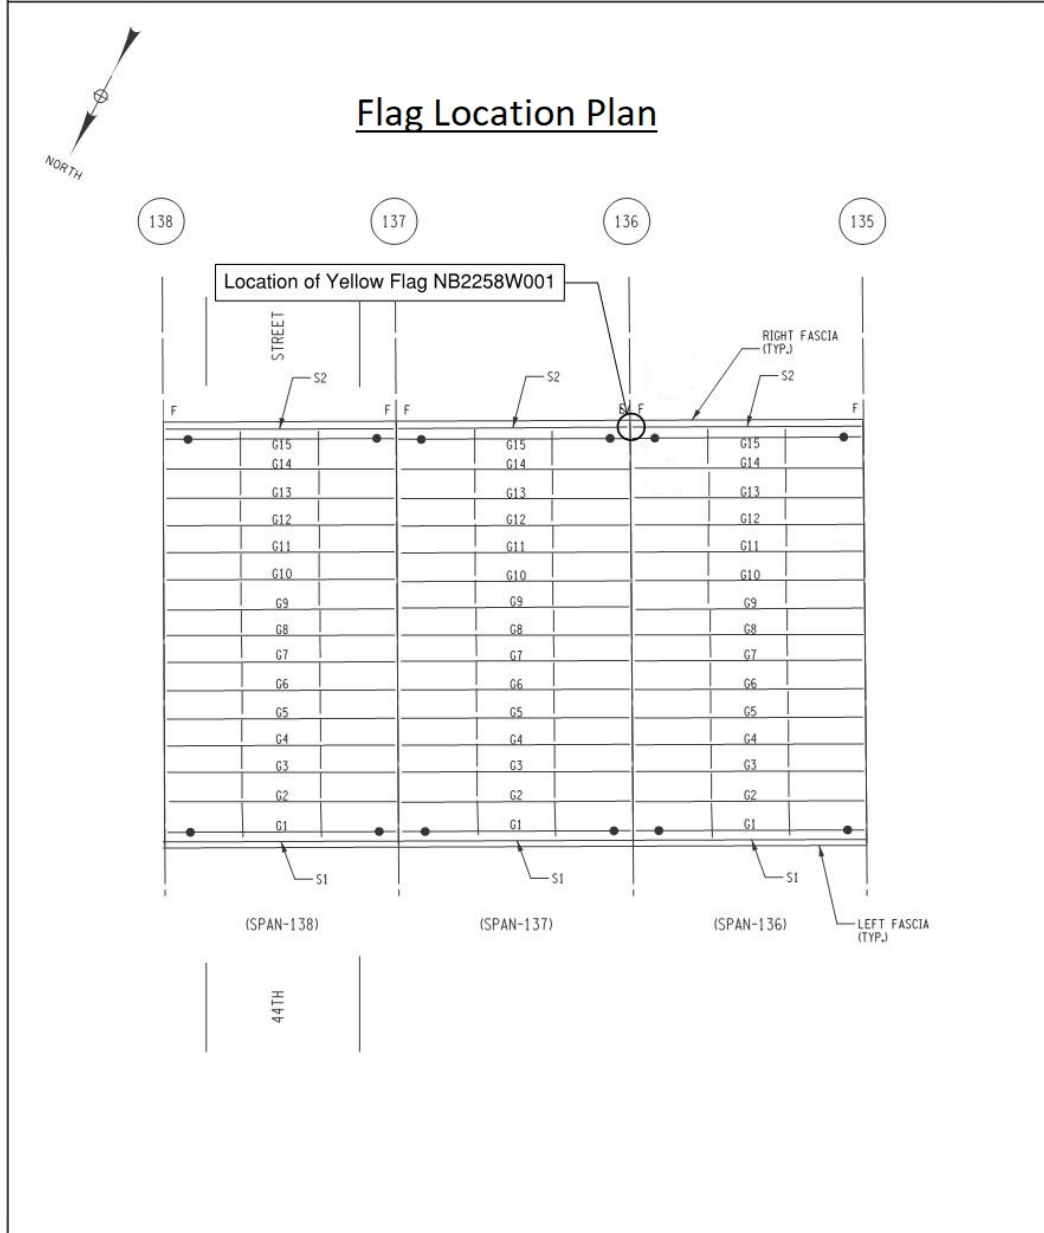
Photo Number: **1**Photo Filename: **22\_Flag Location Plan.jpg**

**Attachment Description: Flag Location Plan**

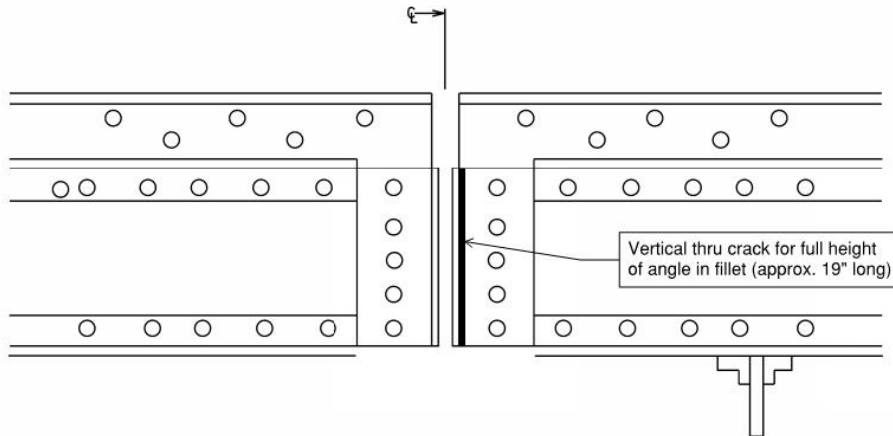
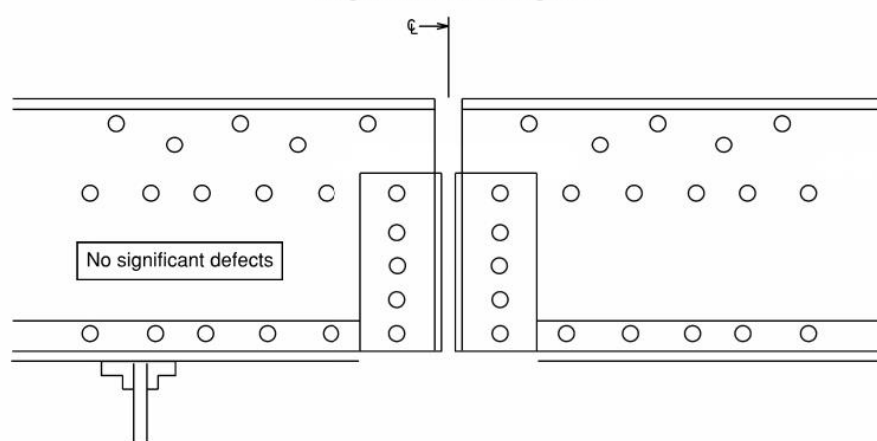
Photo Number: 2

Description: The end of Stringer S2 on Span 136 side of Pier 136 exhibits a full height thru crack along the fillet of the left connection angle at the face of the stringer (Photo 4). The right connection angle at the stringer is in good condition. The stringer web has previously installed steel reinforcement plates which exhibit no significant defects. (Photo 5) The bearing plates below the stringer exhibit no significant defects. Refer to Yellow Flag Condition sketch (Photo 2) for more details.

**Attachment Description: Yellow Flag Condition Sketch**

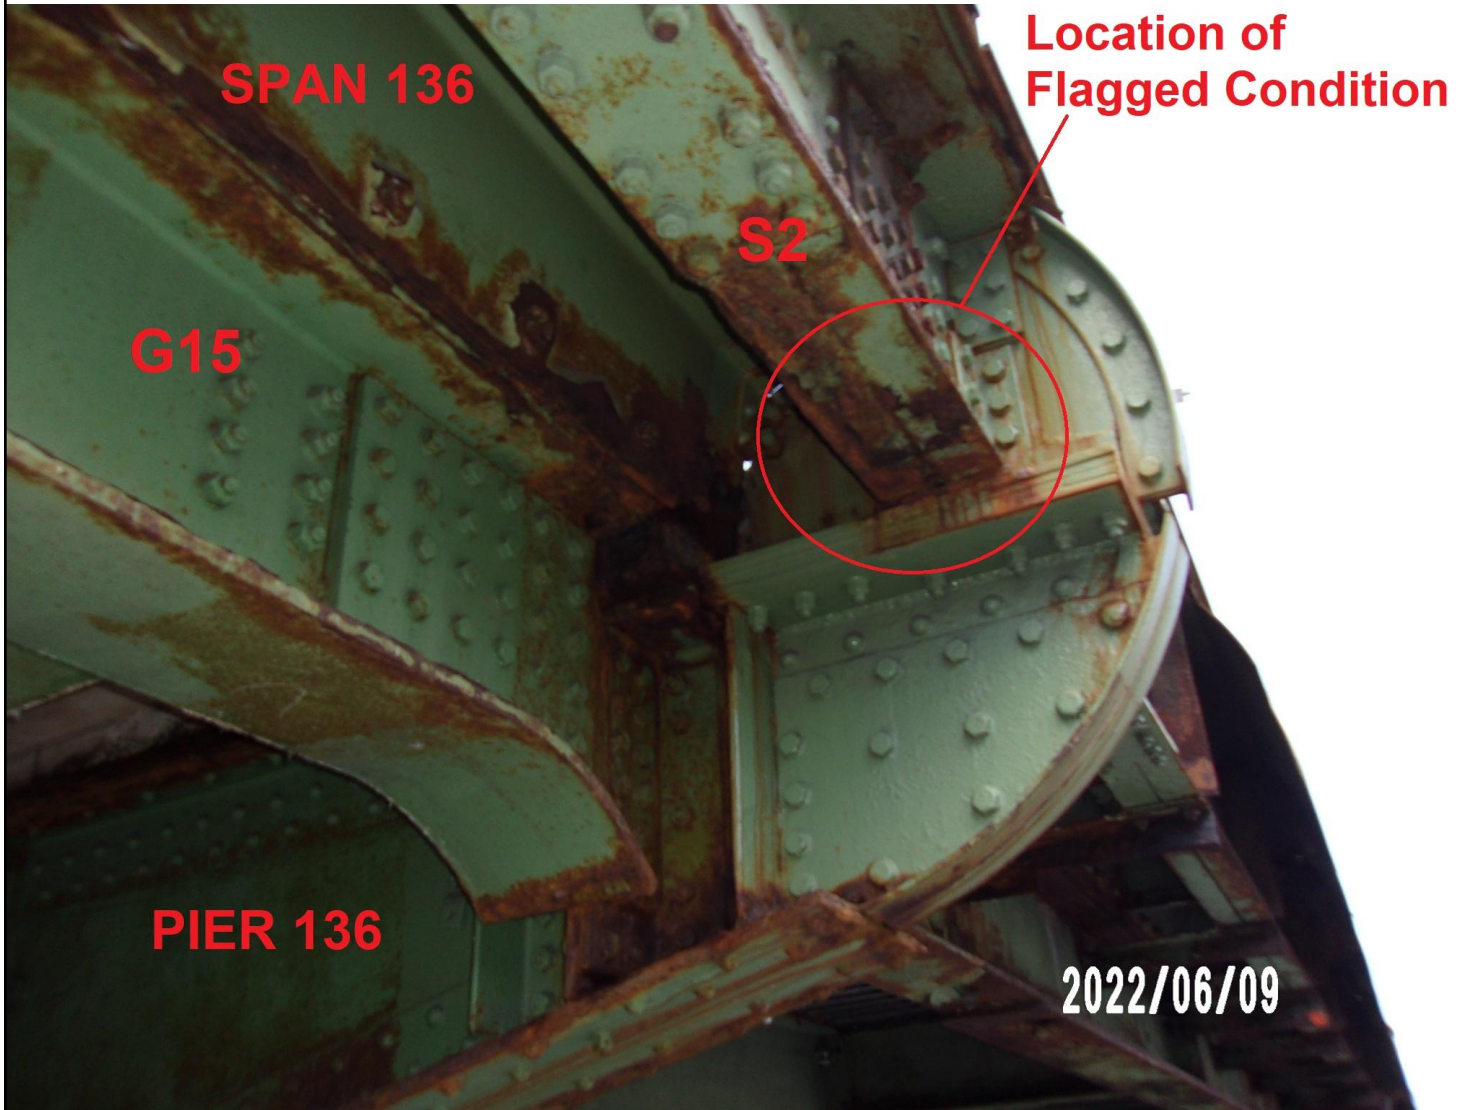
Photo Number: 3

**Attachment Description:** General view of Stringer S2 in Span 136 at Pier 136. Looking End and Left.

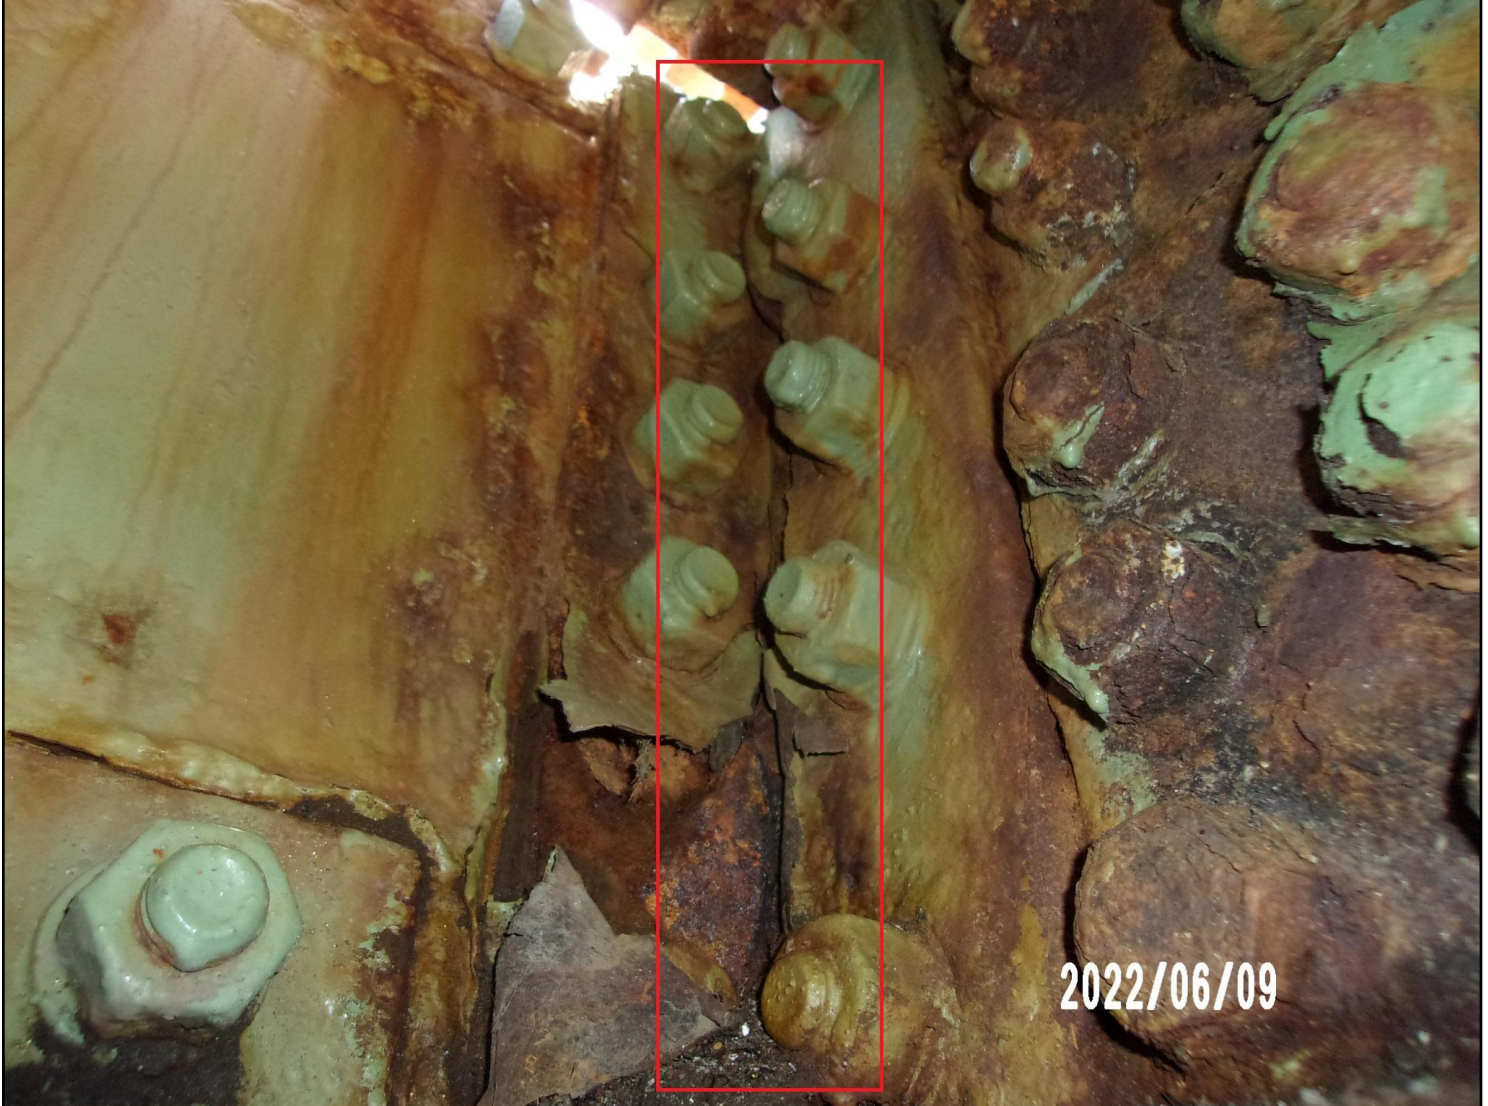
Photo Number: 4

**Attachment Description:** The left face of Stringer S2 in Span 136 at Pier 136. The connection angle at the face of the stringer exhibits full height vertical crack along the angle fillet. Looking End and Right.

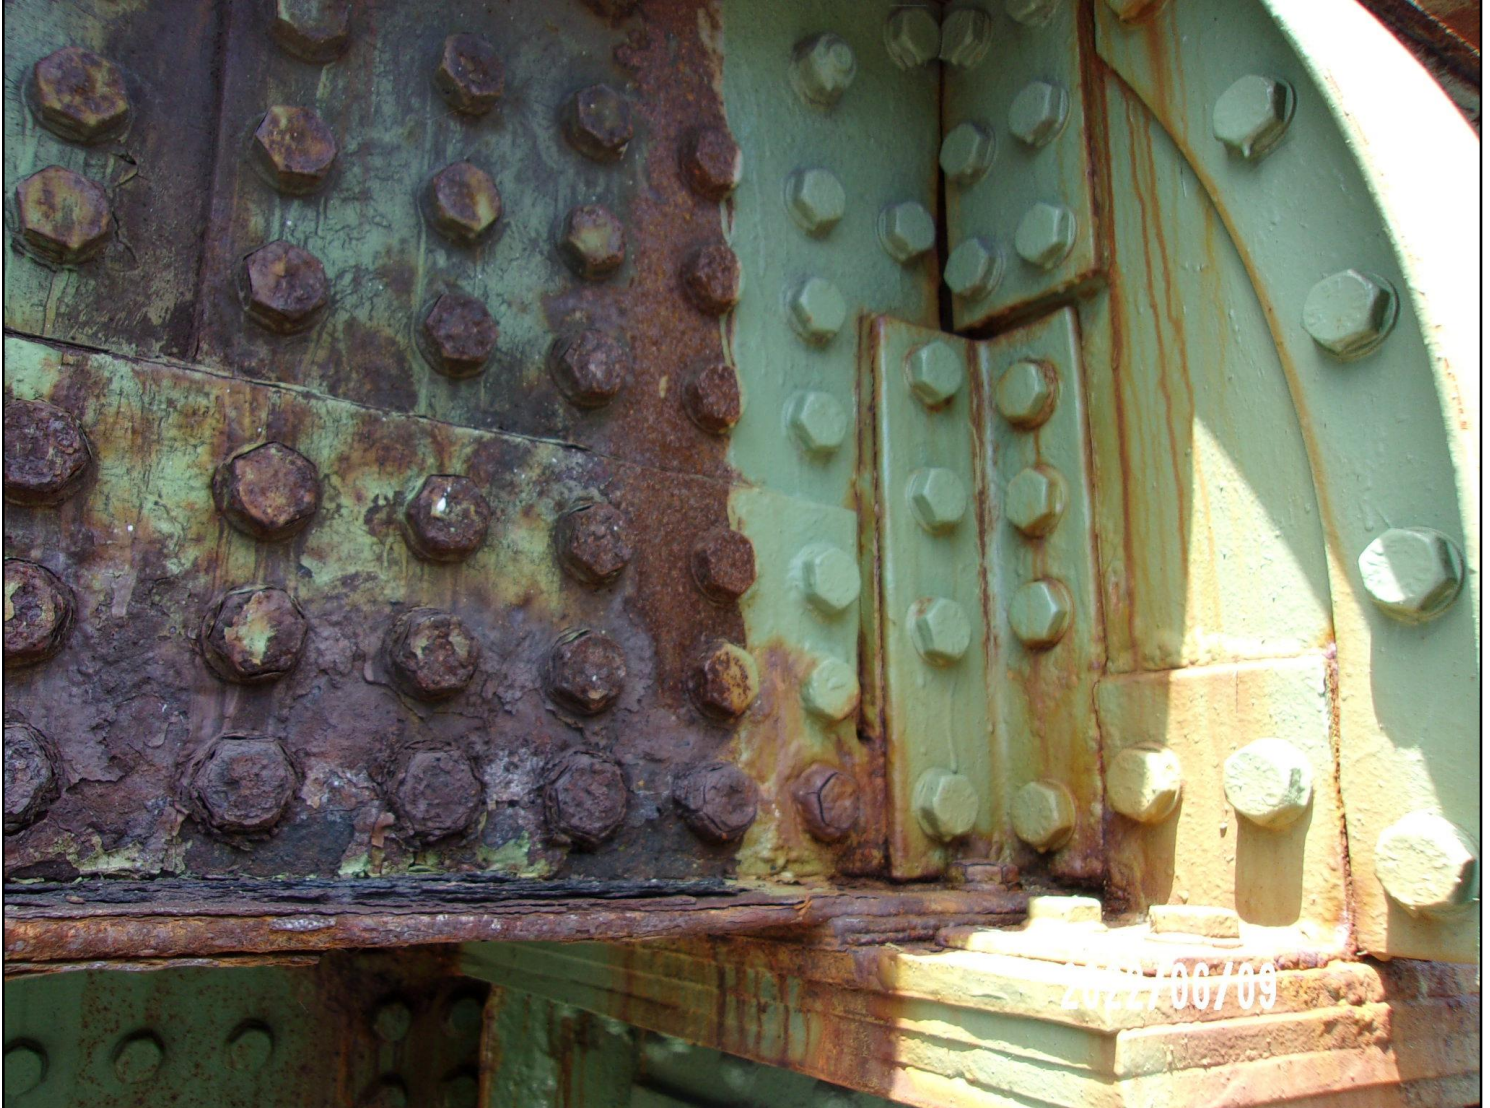
Photo Number: 5

**Attachment Description:** The right face of Stringer S2 in Span 136 at Pier 136. General view of the steel reinforcement plates and angles and right connection angle at the stringer. Looking End and Left.
